Worldwide repairs carried out with PolymerMetal<sup>®</sup>

REP-# 025

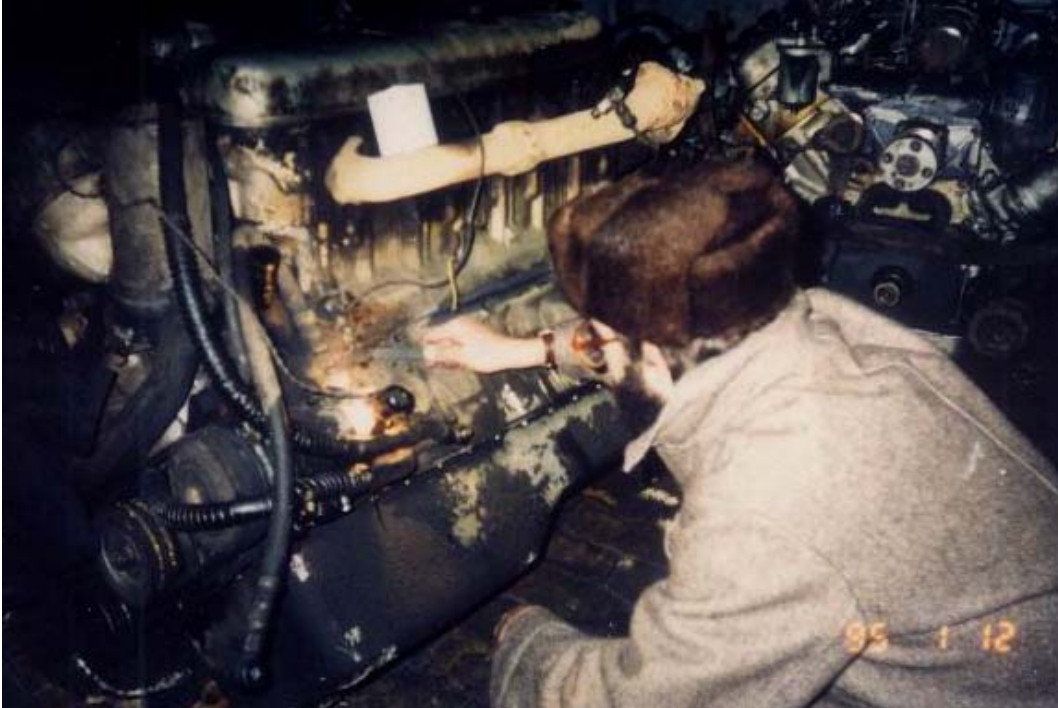
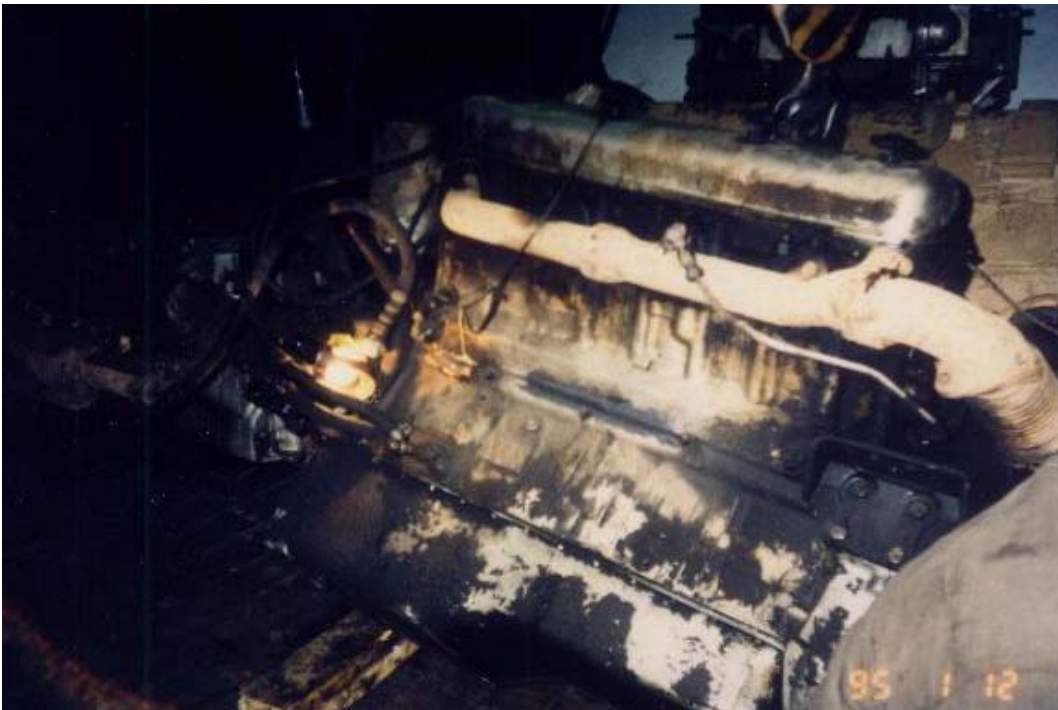
Repair of four cracks on the cylinder block of a big engine called „Super MAZ“ were repaired with MM-metal SS-steelceramic and Hardener yellow. One of the cracks passed the oil channel and was therefore sealed with MM-metal oL-steelceramic and Hardener red.
